INVESTIGATION OF 3"/70 CARTRIDGES FROM AMMUNITION LOT PV-4-C-57

Date: 23 February 1961

NWL REPORT NO. 1741

The premature ignition of a 3"/70 cartridge aboard the USS WILLIS A. LEE (DL-4) resulted in a serious casualty. Various tests with cartridges and cartridge components from the same ammunition lot, PV-4-C-57, failed to reproduce a similar preignition. It was concluded that: the cartridges from ammunition lot PV-4-C-57 appear to be serviceable; the premature ignition, upon ramming, of a 3"/76 cartridge probably would not be caused by solid propellant grain slivers or black powder grains becoming lodged between the cartridge case and projectile; the wad for a full case assembly is not adequate for all 3"/70 full service charge assemblies; the proposed bullet pull-out load requirements are unrealistic for the Mk 34 Mod 3 projectile; and that electromagnetic radiation was not the cause of the casualty. It was recommended that two Pc. No. 26 (wads) be used in a full case assembly, a wad of 4-inch diameter be adopted and used together with two distance pieces whenever Pc. No. 26 is inadequate; i. e., for a PPD range from 2".2 to 4".5 inclusive, and the proposed bullet pull-out loa

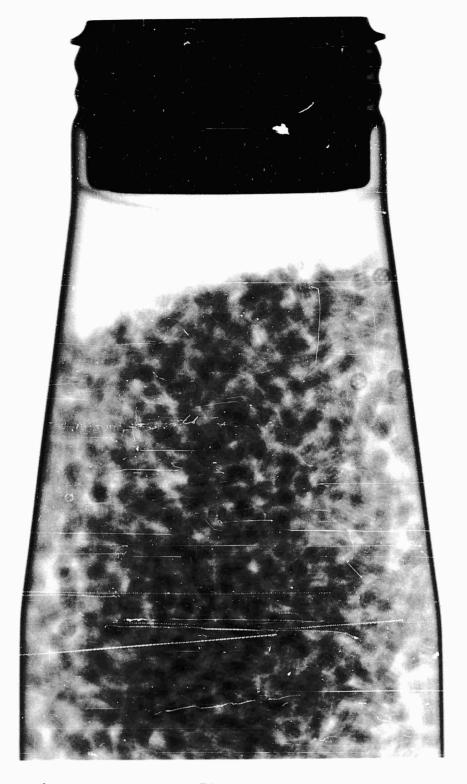
Figure 1

Wad component of the assembly next to the base of the projectile.

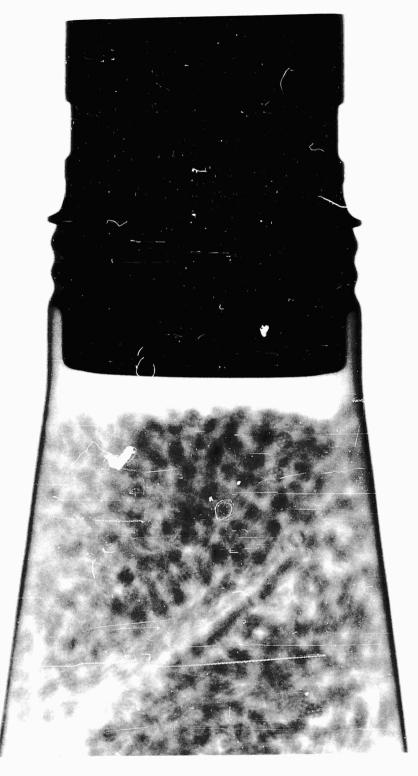
Figure 2

Wad component of the assembly beneath the surface of the propellant bed.

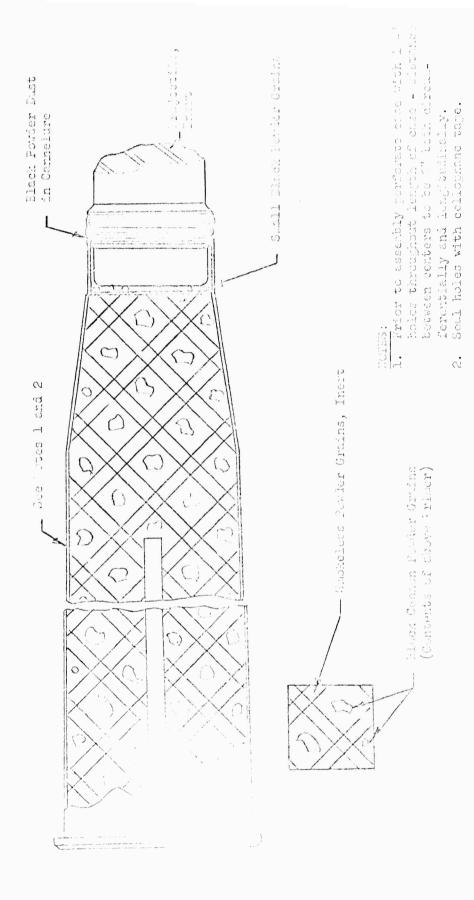
Figure 5

- 5. Outline drawing of 3"/70 cartridge assembly with black powder grains and dust at various locations.
- 6. Radiograph of the first special round showing sectioned solid propellant grains remaining after one cycle through the Mk 37

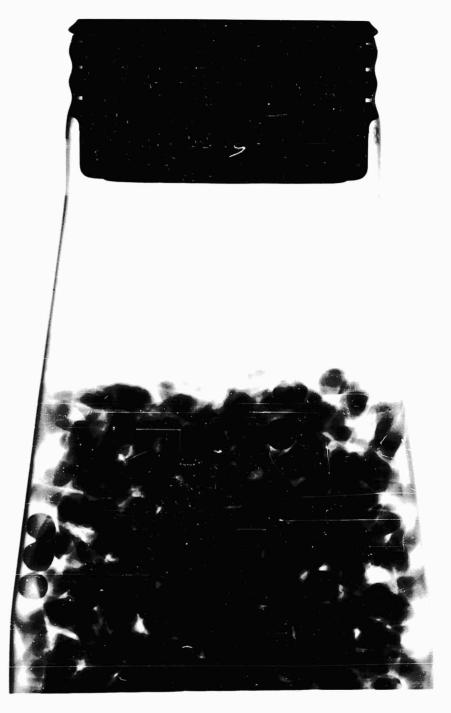
Figure 6

First special round showing sectioned solid propellant grains remaining after one cycle through the Mk  $37\ \mathrm{Mount}$

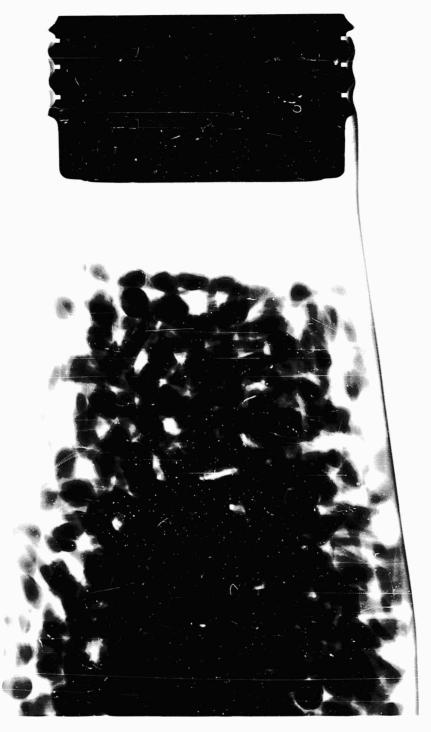
PHD-55649-4-60 Figure 8
Second special round showing sectioned solid propellant grains remaining after ten cycles through the Mk 37 Mount. Rotated 30 degrees from Figure 7.
